**Yankton County
2020 Bridge Inspections**

Presented by:
Adam Polley, PE

Inspection Overview

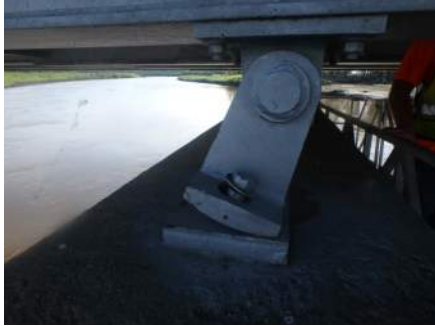
Typical Bearing at Bent 3

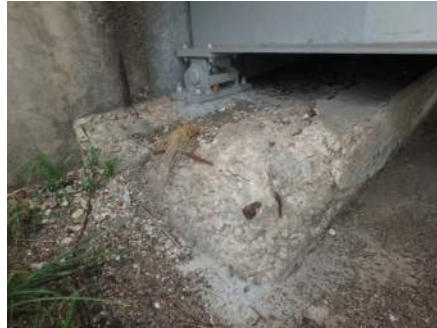
Concrete Deterioration East
End of Abutment 1

- This structure is nearing the end of its useful life and should be programmed for replacement.
- Continue to post the structure at Single Unit: 11 Tons, Combinations: 13 Tons.
- Note: This structure is scheduled to apply for a replacement grant in January 2021.

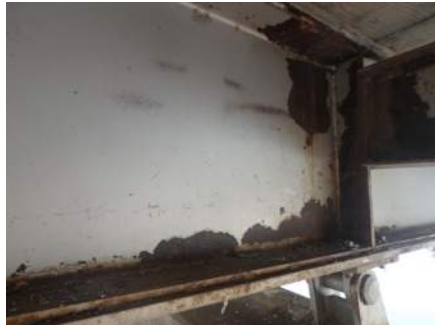
Corrosion of Girders over the
Bents

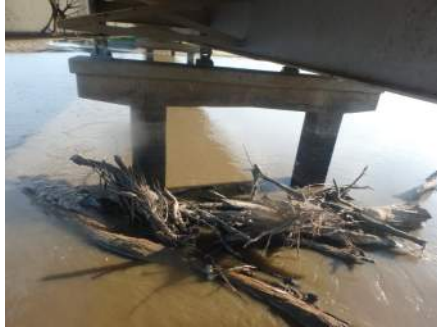
Tree Debris at Bent 2

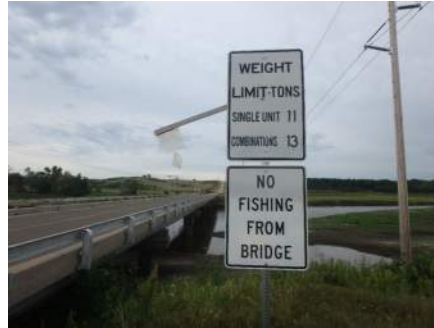
Weight Limit Sign

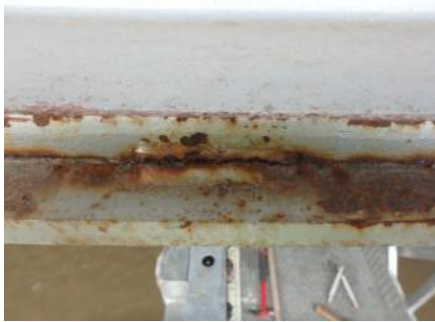
Broken Weld on Girder 4 in Span 2 on Cover Plate (Typical to numerous locations)

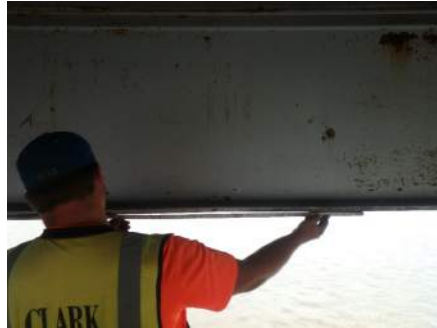
Bent Girder 3 at End of Cover Plate in Span 3

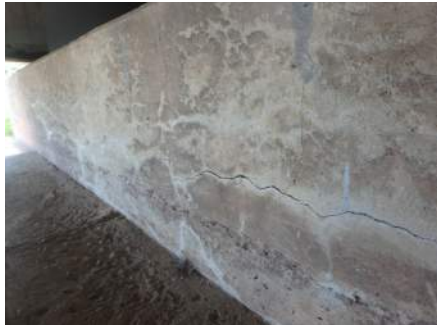
Cracking on Abutment 1 Sill

- Remove the debris from the top of the bent caps and abutment sills.
- Repair the deteriorating substructure elements.
- This structure is nearing the end of its useful life and should be programmed for replacement.
- Continue to post the structure at Single Unit: 24 Tons, Combinations: 31 Tons.

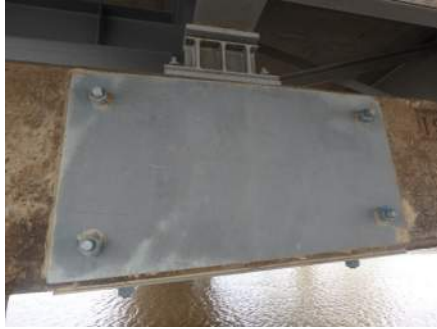
Bent Cap Repair on Bent 5

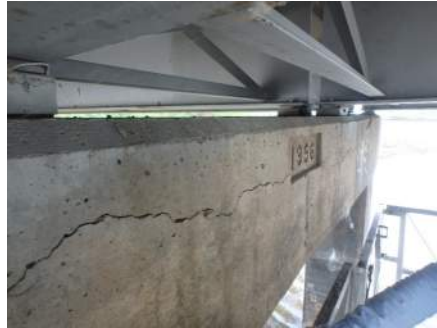
Cracking on the South Face of Bent Cap 6

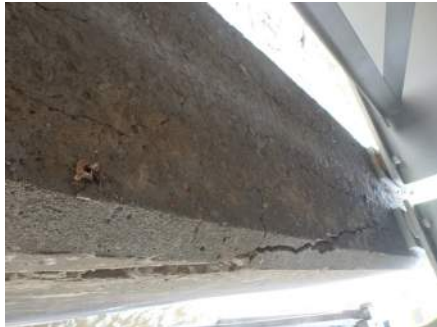
Crack on the Top of Bent Cap 6 East End

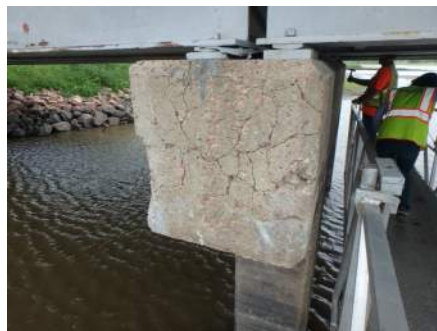
Condition of the West End of Bent Cap 6

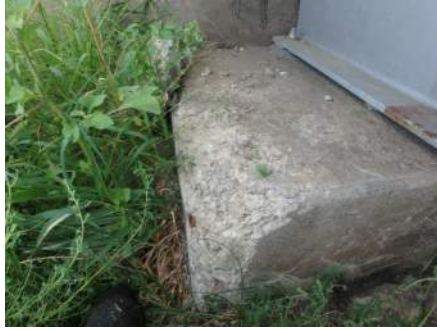
Concrete Deterioration on the West End of Abutment 7 Sill

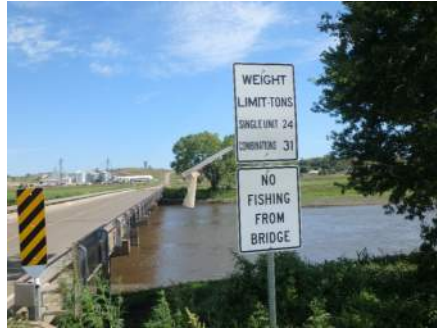
Weight Limit Sign

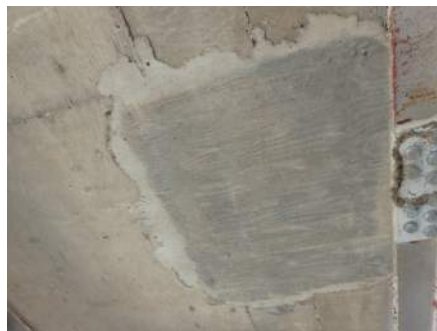
Concrete Patching on the Underside of the Deck at Bolted Splice Locations

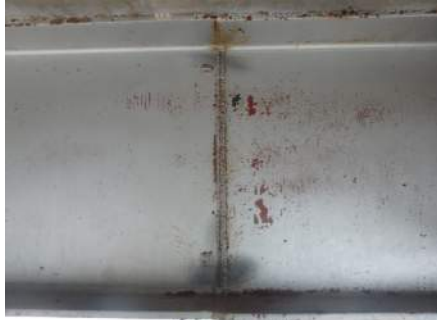
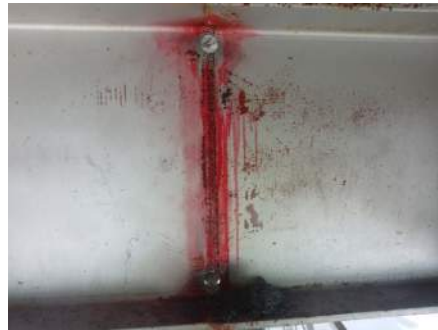
Cracked Splice on Girder 3 in
Span 4 West Splice

Cracked Splice on Girder 3 in
Span 4 West Splice (Testing
and Crack Tips)

- Install bolted splice at the cracked weld splice location.
- Remove the tree debris around Bents 3 and 4.
- Continue to post the structure at Single Unit: 24 Tons, Combinations: 32 Tons.

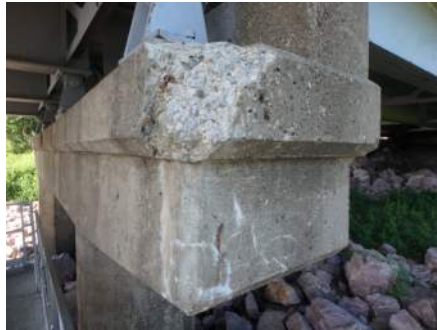
Concrete Deterioration on
the North End of Bent Cap 2

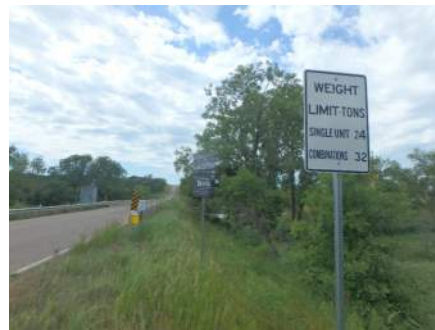
Weight Limit Sign

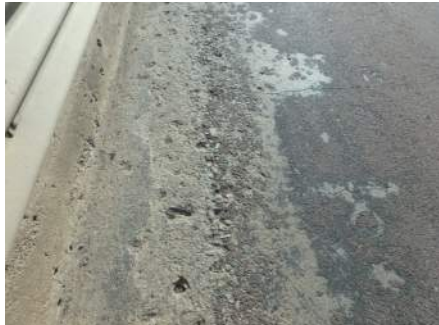
Typical Deterioration of the Edge of the Deck

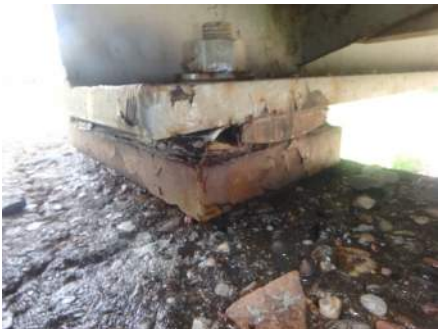
Section Loss of Bearing Plate over Bent 2

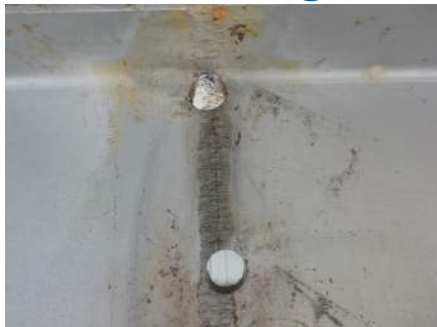
Arrested Crack on Girder 2
Span 3

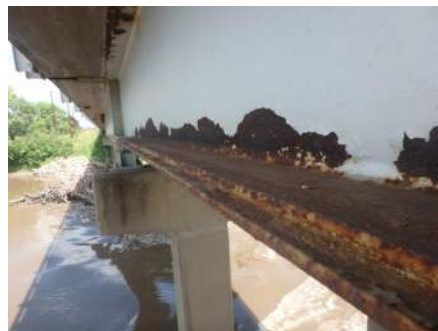
Typical Corrosion to the Exterior
Girders

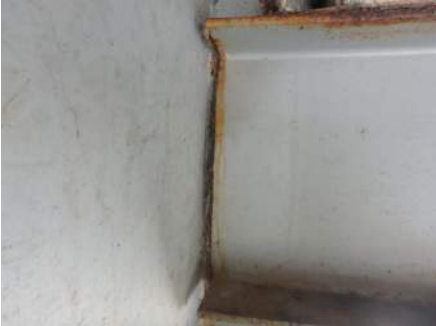
Bulging of Diaphragms from Pack Rust over Bent 5

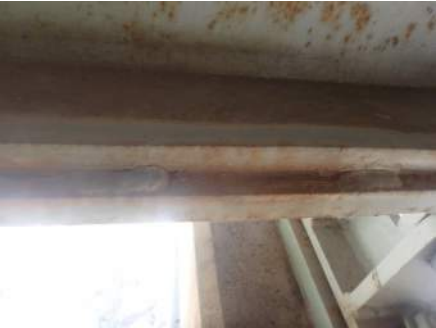
Cracked Weld on Girder 3 over Bent 5 on the Cover Plate

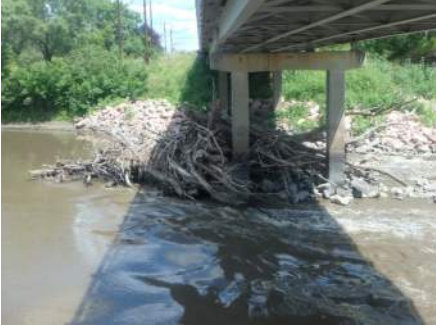
Tree Debris at Bent 5

- Remove the debris from the abutment sills and the bents.
- This structure is nearing the end of its useful life and should be programmed for replacement.
- Remove the tree debris from under the structure.
- Continue to post the structure at Single Unit: 24 Tons, Combinations: 33 Tons.
- Note: Preliminary Engineering grant has been awarded and is currently under design.

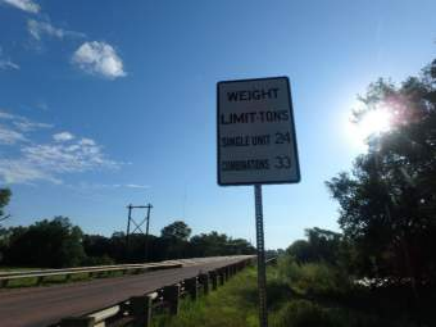
Weight Limit Sign

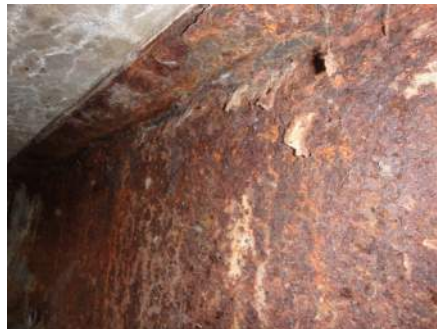
Typical Section Loss to the Web of the Girders

- This structure is nearing the end of its useful life and should be programmed for replacement.
- Post the structure at Single Unit: 12 Tons, Combinations: 21 Tons due to the section loss of the girders.

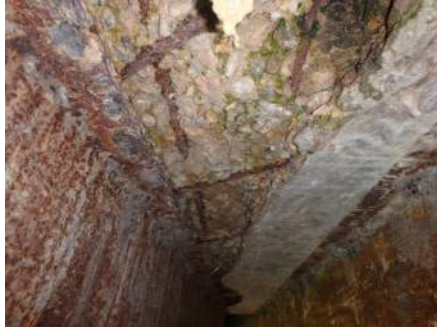
Concrete Deterioration in the Exterior Bays

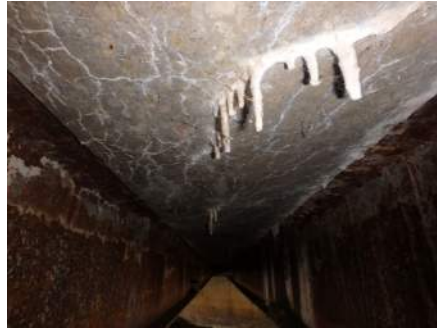
Typical Efflorescence and Stalactites on the Underside of the Deck

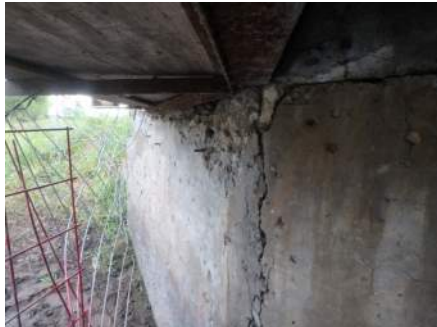
Cracking and Deterioration at the Corners of Abutment 2

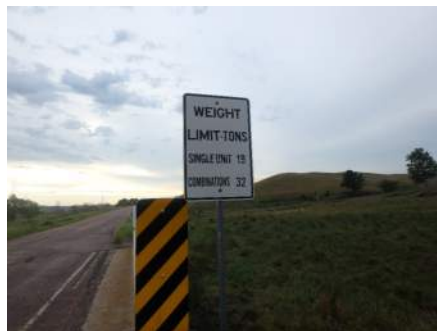
Weight Limit Sign

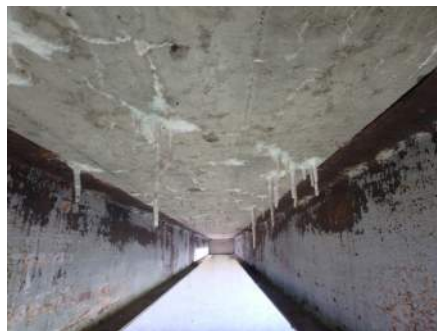
Typical Stalactites Buildup on the Underside of the Deck

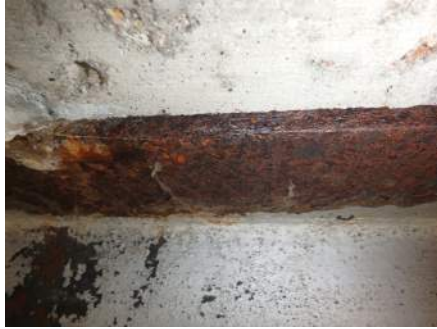
Typical Section Loss on the Top Flange of the Girders

- This structure is nearing the end of its useful life and should be programmed for replacement.
- Continue to post the structure at Single Unit: 17 Tons, Combinations: 29 Tons.

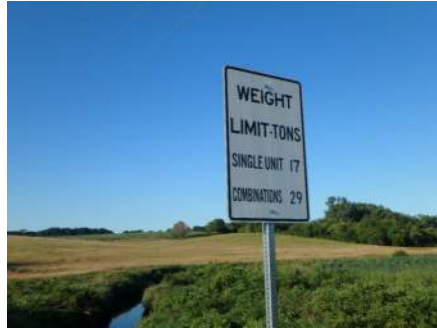
Weight Limit Sign
